Toward Zero Deaths Conference

Pedestrian Crossing Safety

Rectangular Rapid Flashing Beacons (RRFB)

Tom Sohrweide, PE, PTOE
SEH Inc.

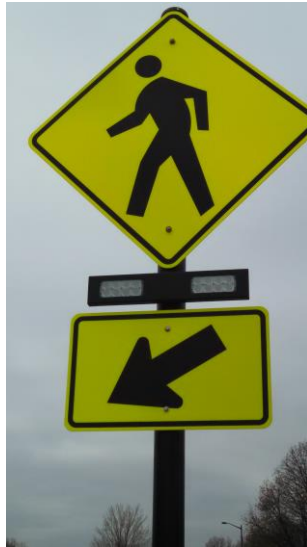
Rectangular Rapid Flashing Beacon

- A dual flasher that uses an irregular flash pattern that is similar to emergency flashers on police vehicles

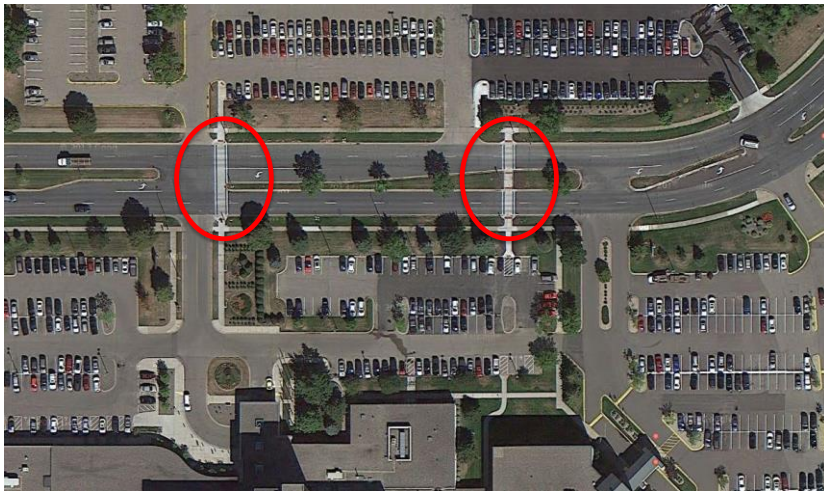
Crosswalk Locations

- 2 Crosswalks
- Advance pedestrian crossing signs
- Pedestrian crossing signs (right side & median)
- Pedestrian actuated RRFB below pedestrian crossing signs
- “STOP Here for Pedestrian” signs in advance of crosswalk
- Stop bars
- In-pavement flashers
